## SPILL REPORT

Husky Oil Operations Limited  
10-07-014-19 W3M

Site Plan

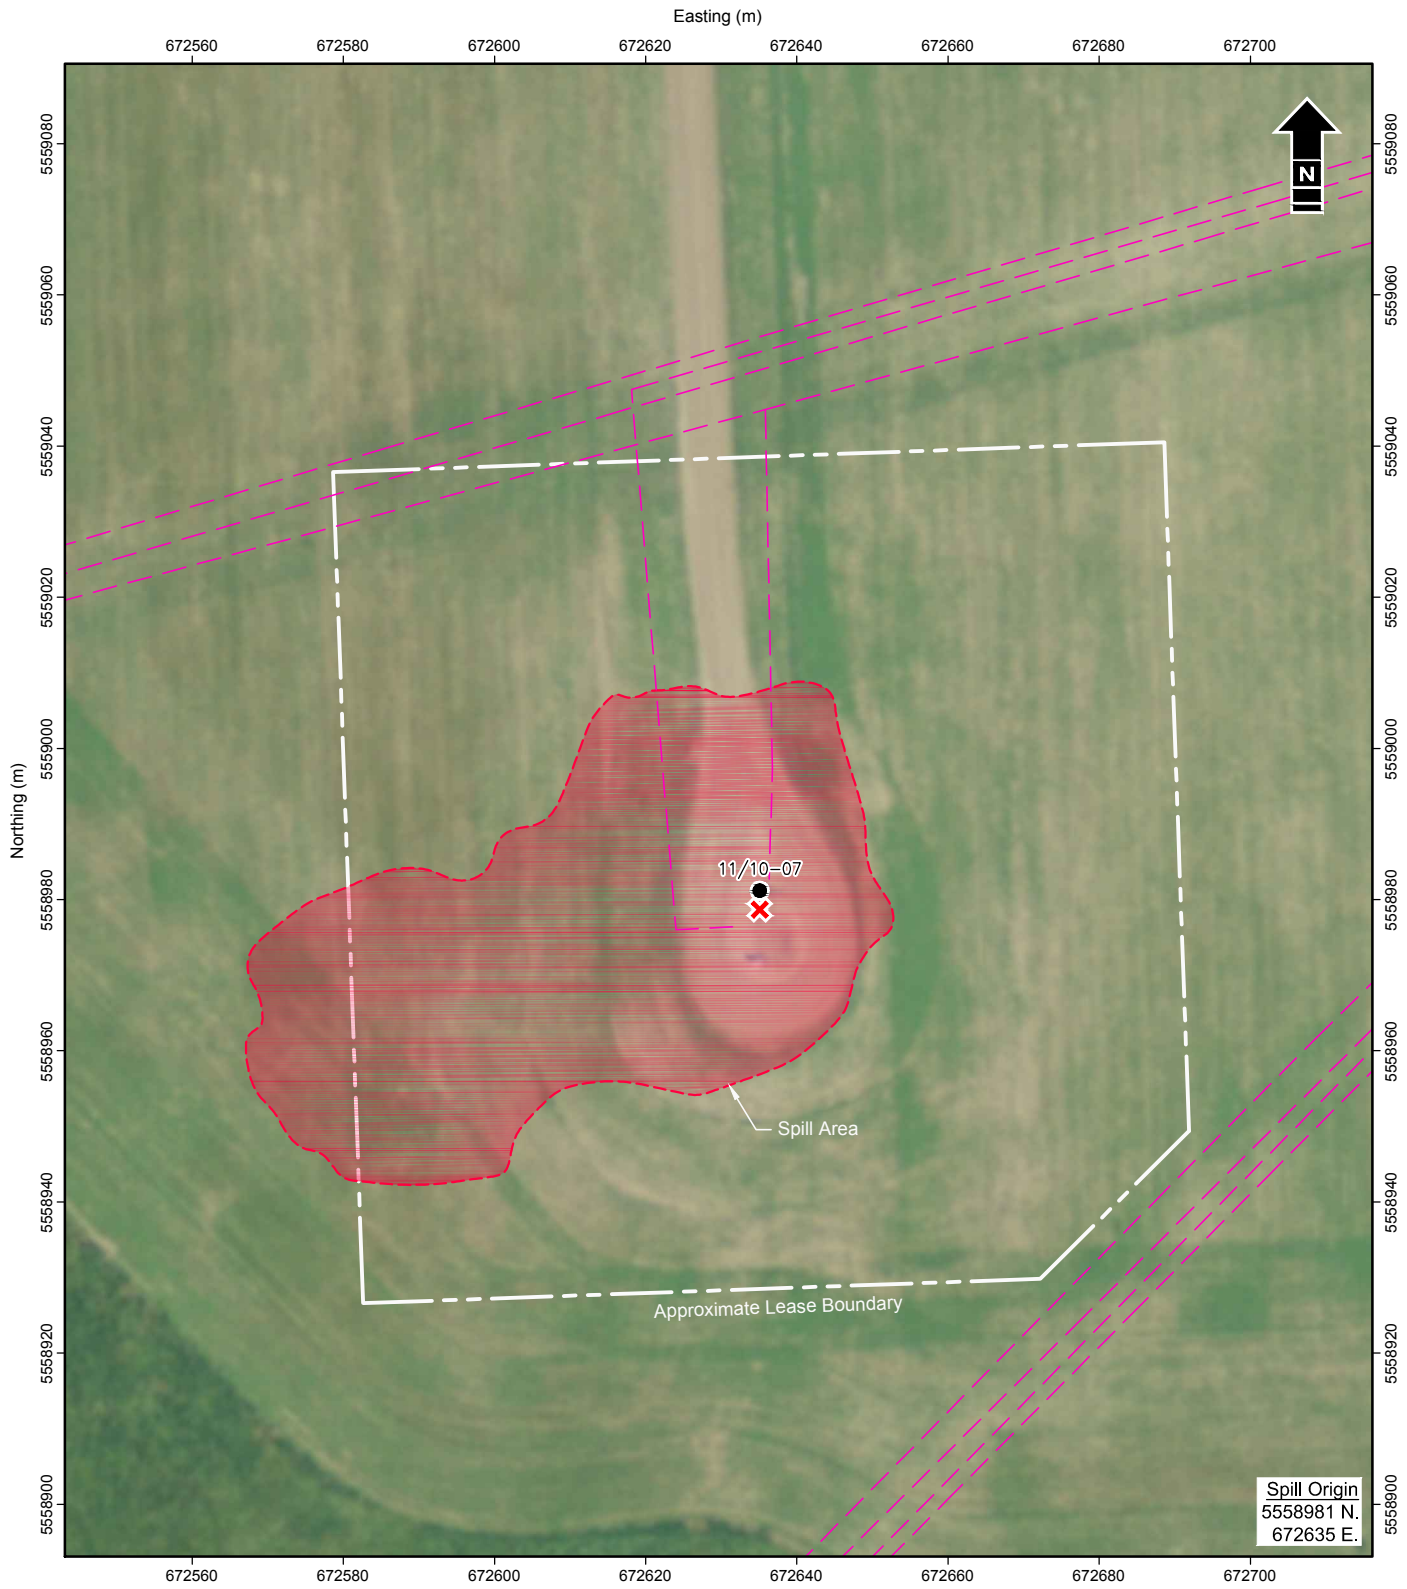
Spill Origin  
5558981 N.  
672635 E.

| Spill Area Summary | |
| Spill Area On-Lease | 3070 m <sup>2</sup> |
| Spill Area Off-Lease | 410 m <sup>2</sup> |
| <b>Total Spill Area</b> | <b>3480 m<sup>2</sup></b> |

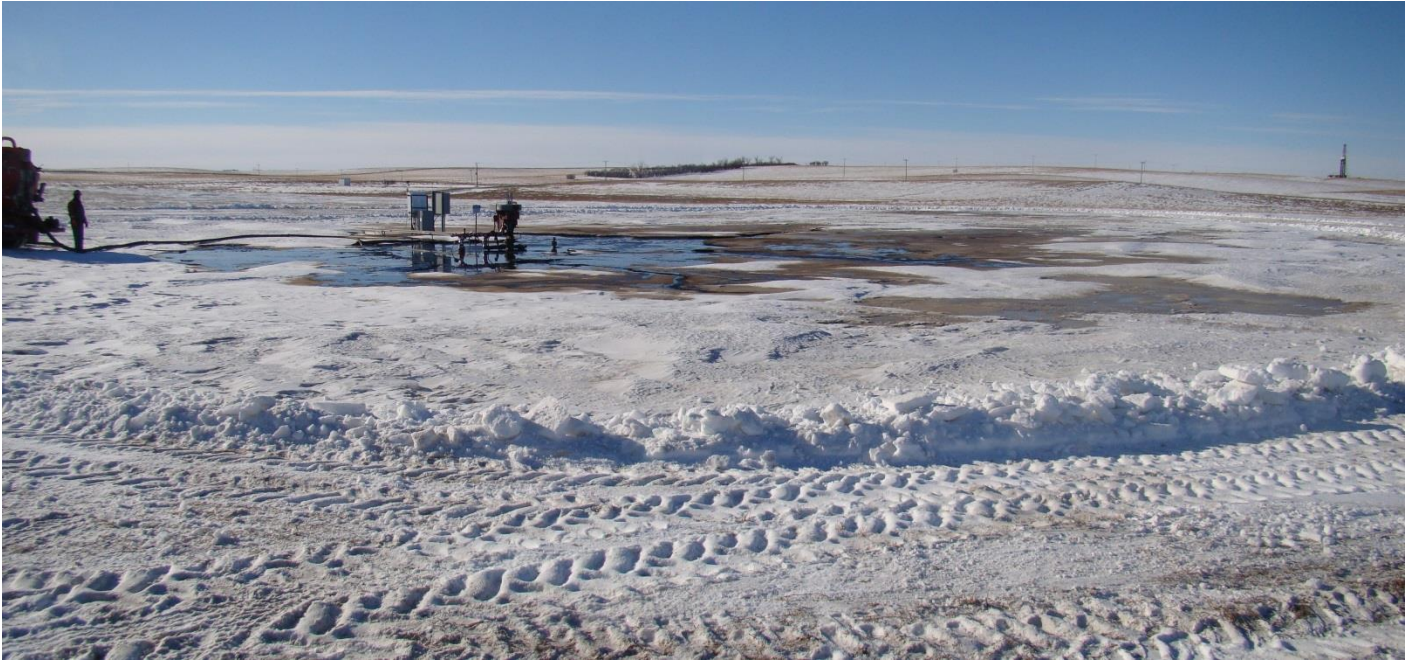
1. Spill path viewing southeast

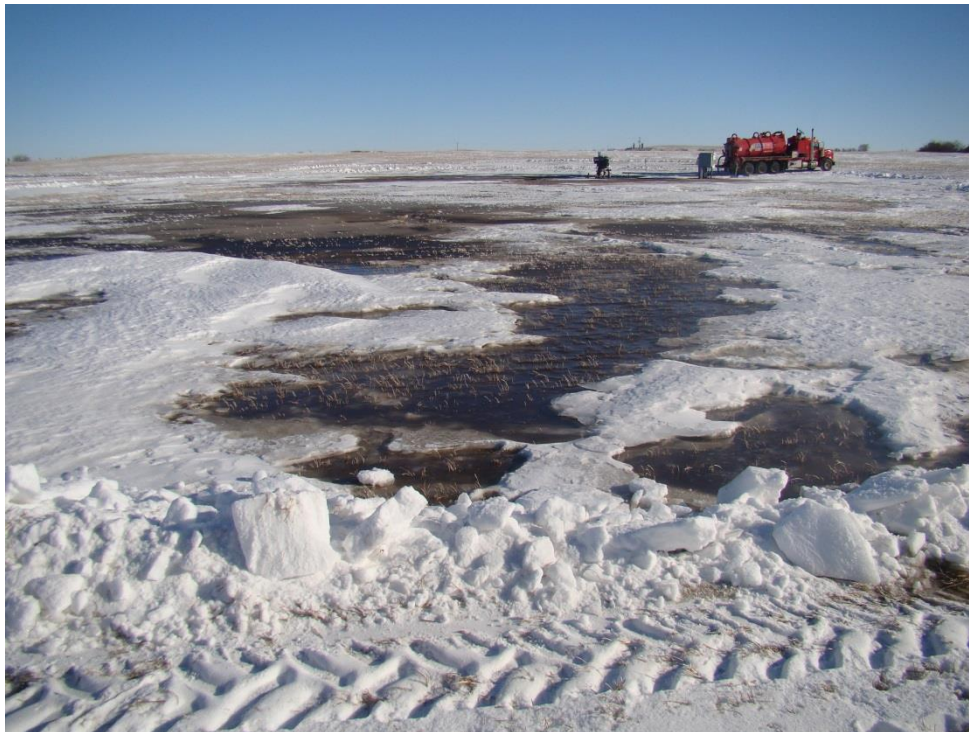
2. Spill extent viewing east

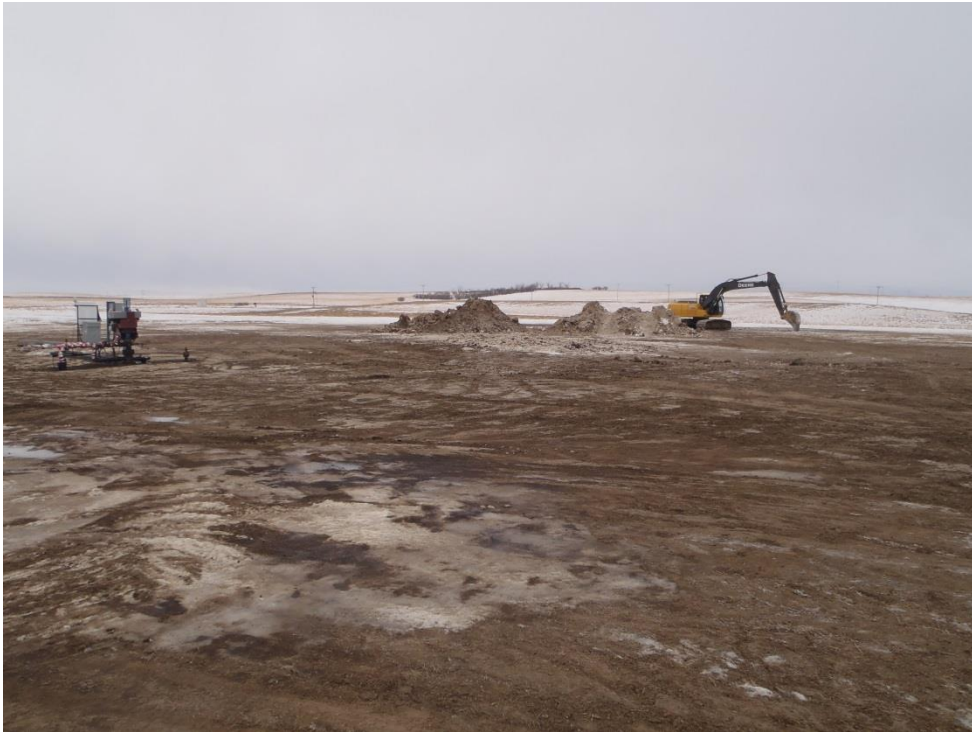
3. Spill path viewing southeast

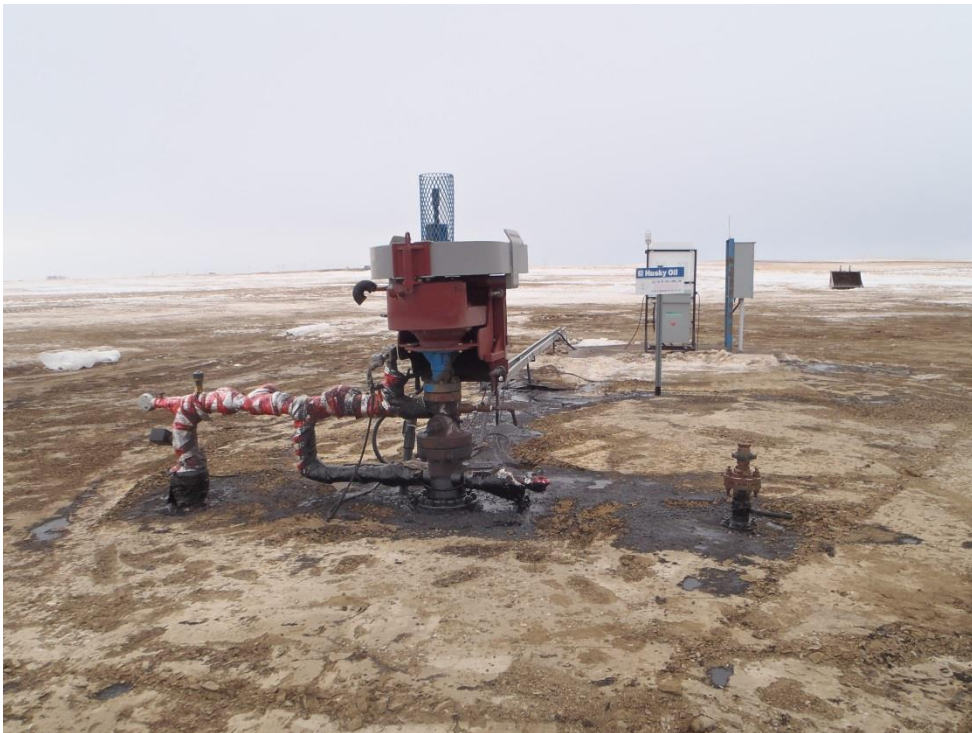
4. Spill origin (11/01-07 wellhead) viewing south

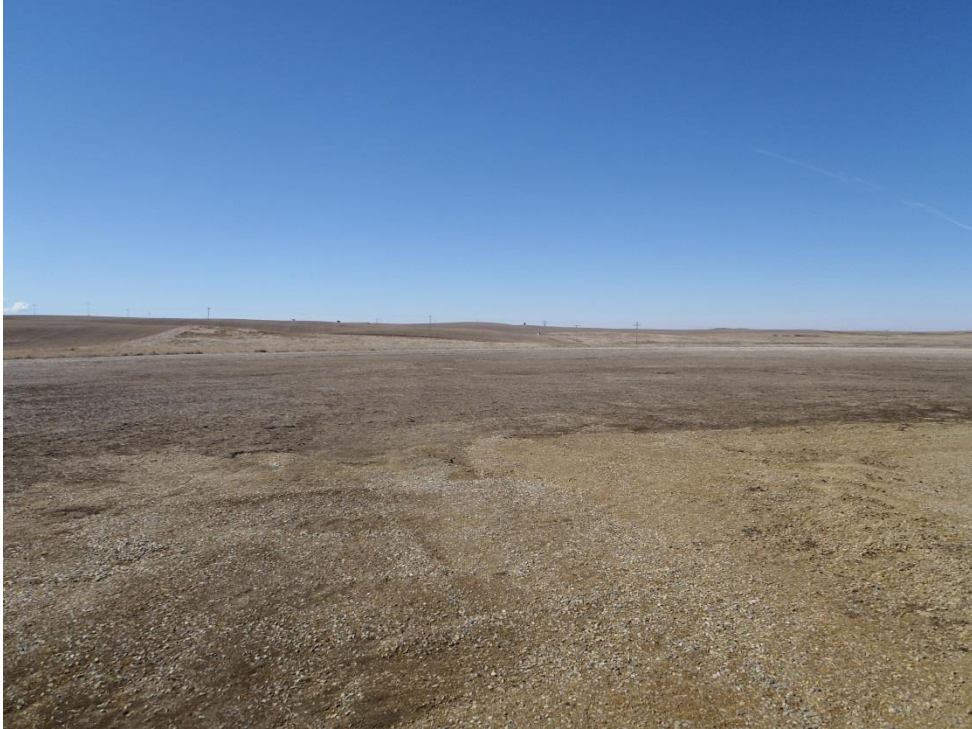
5. Spill area viewing west

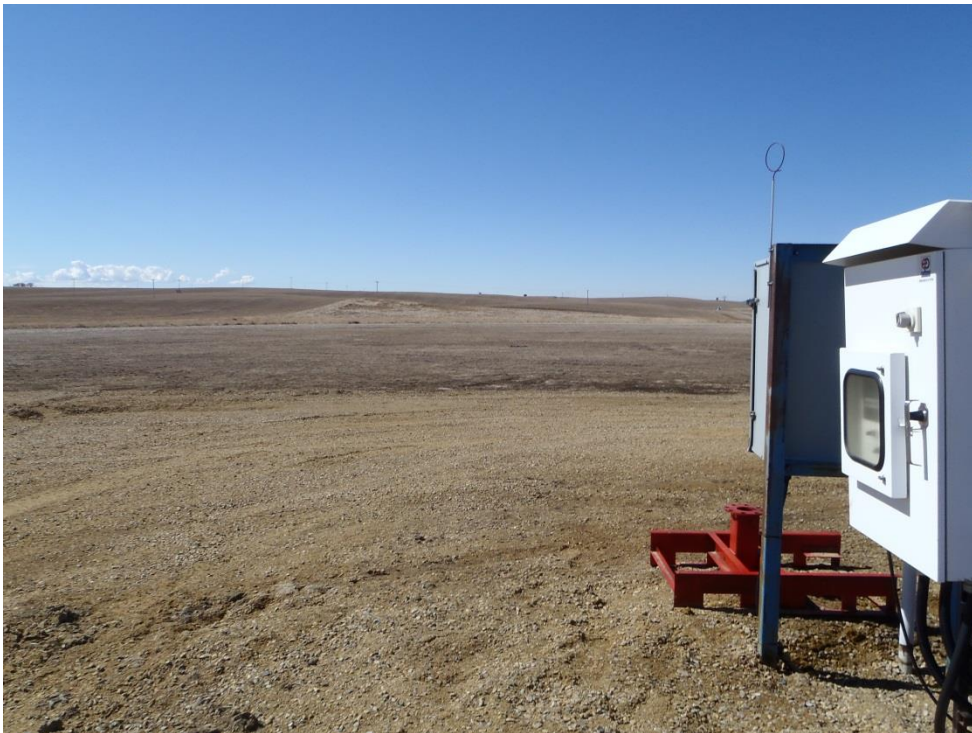
6. Spill origin viewing west
