14-08-14 19W3 19951226

SPILL & MATERIAL FAILURE REPORT

INCIDENT NUMBER
95-02-04-157

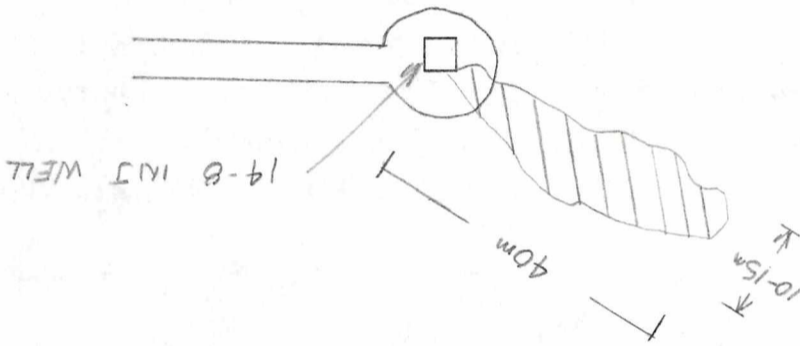
DIAGRAM OF SPILL AREA:

Landowner: DENNIS PENNER Phone No: (306) 672-3975 Crown Land: Yes ___ No ✓
 Occupant: ___ Phone No: () ___
 Contacted by Company: Yes ✓ No ___ Contacted by SEM: Yes ___ No ✓
 Comments: all fluid soaked away before recovery
 Signature: [Signature] SEM - Regina SEM - Field ENV - Canada

Details of Clean-up: ALL FLUID SOAKED AWAY. LCA-II WILL BE WORKED INTO SOIL IN SPRING

Details of Repairs Conducted: VALVE & NIPPLE REPLACED

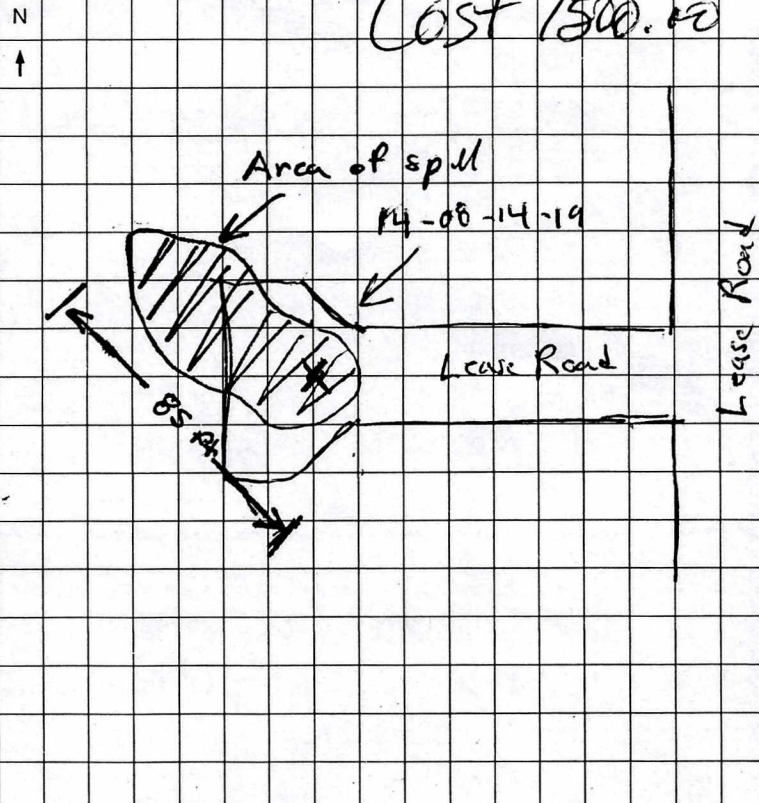
If more space needed, attach extra sheet.
while checking Fry well I went to 14-08-14-19 and found master valve to be leaking around bonnet. It appears gasket and face of bonnet washed out.

Wellhead equipment leak

Well was S.I., Tubing was bled down to tank truck and master valve was replaced.

Master Valve Dec 23 /95
