CONSERVATION BULLETIN SERIES

Standards & Guidelines

FOR THE CONSERVATION OF HISTORIC
BUILDINGS IN SASKATCHEWAN

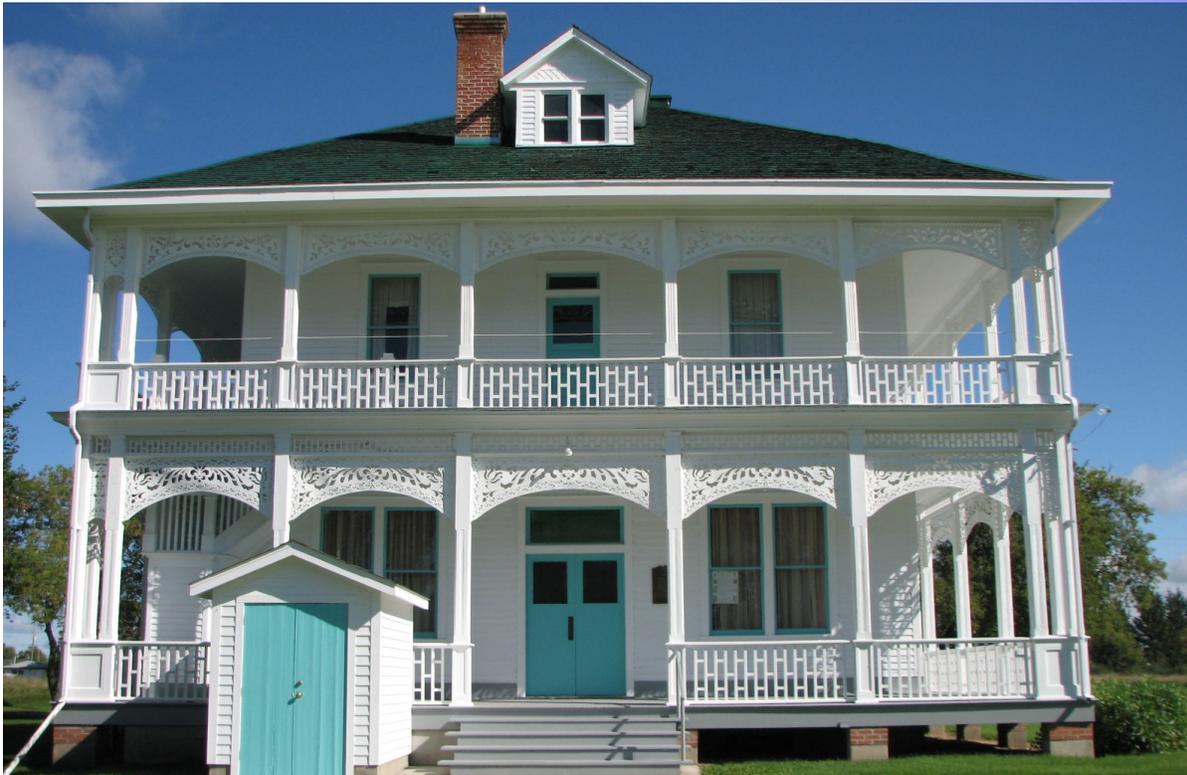
Fig. 2—Doukhobor Prayer House, Veregin (Photo: M.G. Miller 2010).

Discussion: When the maintenance, repair and re-painting of the exterior balustrade and upper floor deck was undertaken at the Doukhobor Prayer House in 2010, it represented the preservation of its character-defining elements.

Discussion: Since the approach taken was one of retaining wood that could be repaired, it is considered an intervention that meets the Standards & Guidelines.

Piecing-in of new wood to reinforce the historic wood is now visible upon close inspection. Extensively deteriorated balustrades were replaced in kind, and were based on the physical evidence on the site.

That there was evidence on site enabled an accurate piecing-in of wood members. However, in situations where evidence is not available, the Standards & Guidelines do not recommend guessing or conjecture.

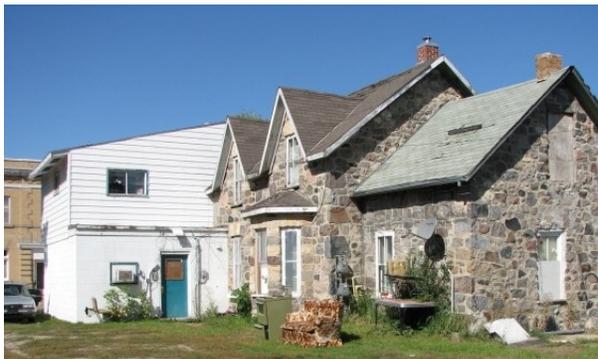
Fig. 3 — Stone House, Fort Qu' Appelle
(Photo: Ken Collum, 2009)

Recovering an earlier form may also include the removal of non-contributing additions or alterations such as those depicted in Fig. 3.

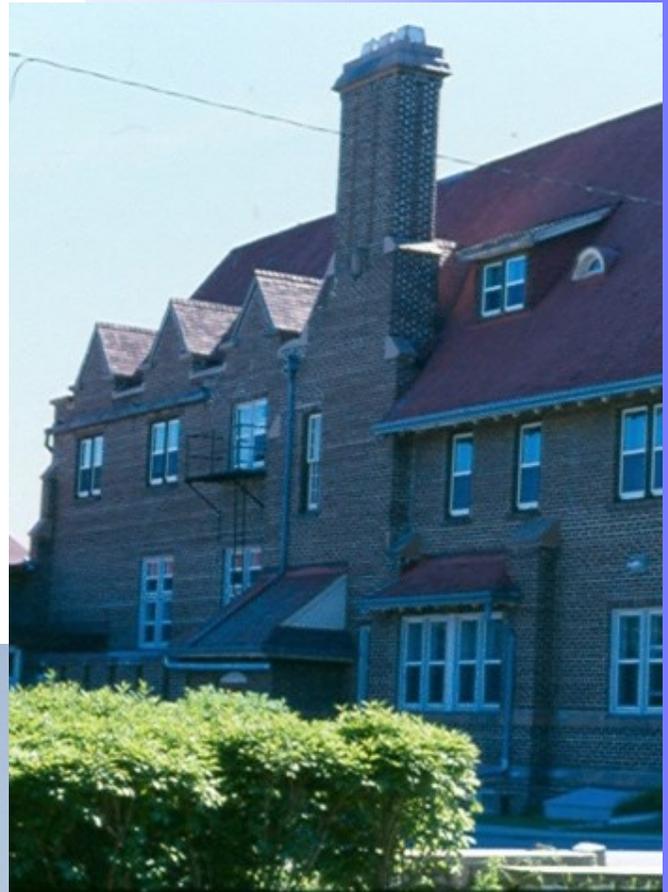
Fig. 8— St. Chad’s College, Regina.
(Photo: F. Korvemaker 1979)

Discussion: When the former St. Chad’s College in Regina was adapted to accommodate a new use, it included the construction of over-sized dormers with window openings of a proportion that would not be considered a “sensitive” adaptation of the building. In addition, the historic double-hung wood windows were replaced by “picture” windows without mullions.

The result of this intervention is to visually change the building’s appearance. In situations where there are no remaining historic windows, there are no “regulatory” obligations on the property owner to “restore”, the windows to a particular period. In order to meet the Standards & Guidelines, however, it would be necessary to design a “compatible” window that respected the heritage character of the place. This would be considered rehabilitation.

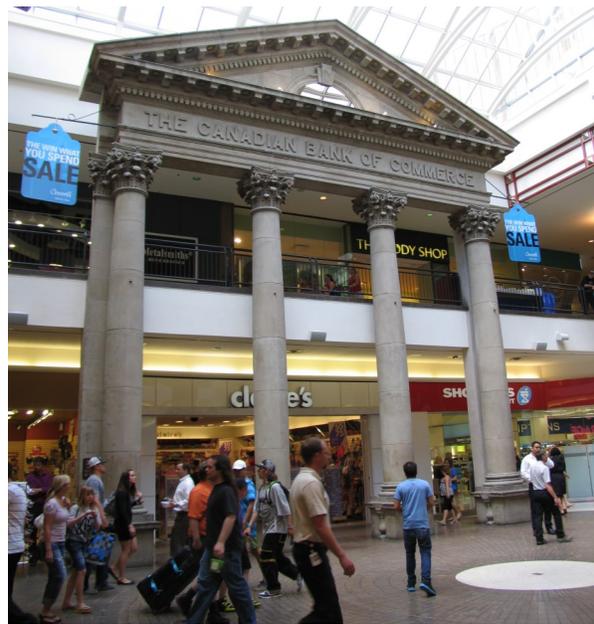
Fig. 9 —Remnants of the Canadian Bank of Commerce relocated to the Cornwall Centre, Regina (Photo: M. G. Miller, 2011)

Further, the relocated remnants of the Canadian Bank of Commerce highlights key principles in Standard 4 where a false sense of historical development results from combining features of the property that never co-existed.

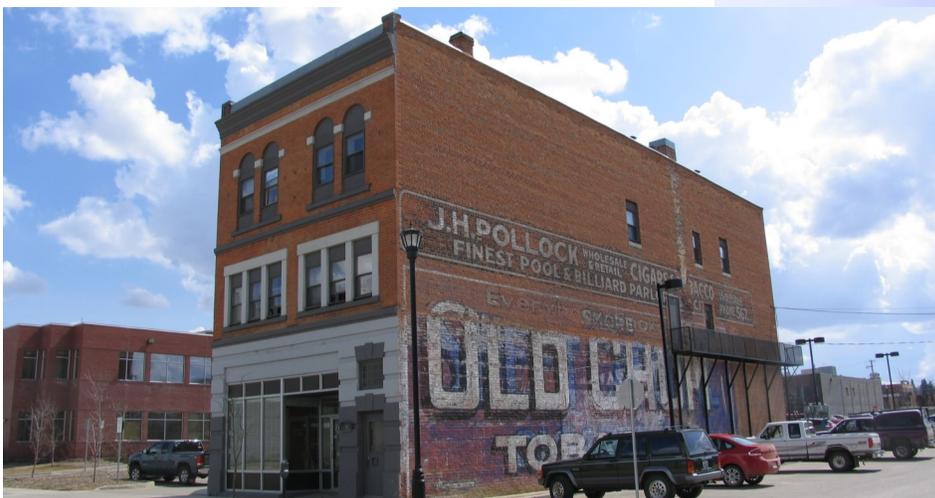
Fig. 12—Main Street, Prince Albert (Photo: M. G. Miller, 2011)

which are not. In relation to the windows in Fig. 12 for example, such a change, where the windows inserted do not fit the original opening, need not be conserved.

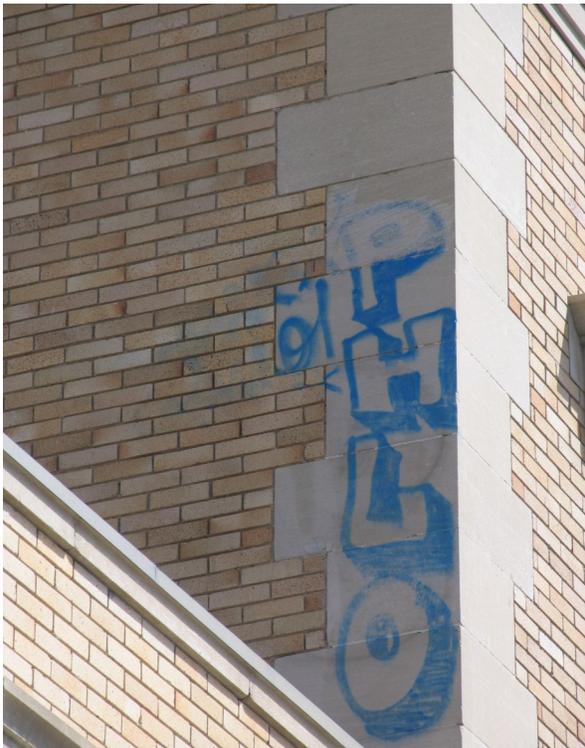
Fig. 13 — Regina Telephone Exchange, Regina (Photo: M. G. Miller, 2011)

Minimal intervention can also mean using very delicate techniques in order to safeguard historic material, features or finishes. For example, when paint is applied onto porous masonry such as limestone, removal methods need to be very carefully considered to reduce the possibility of permanent damage that might arise when aggressive or abrasive methods are used.

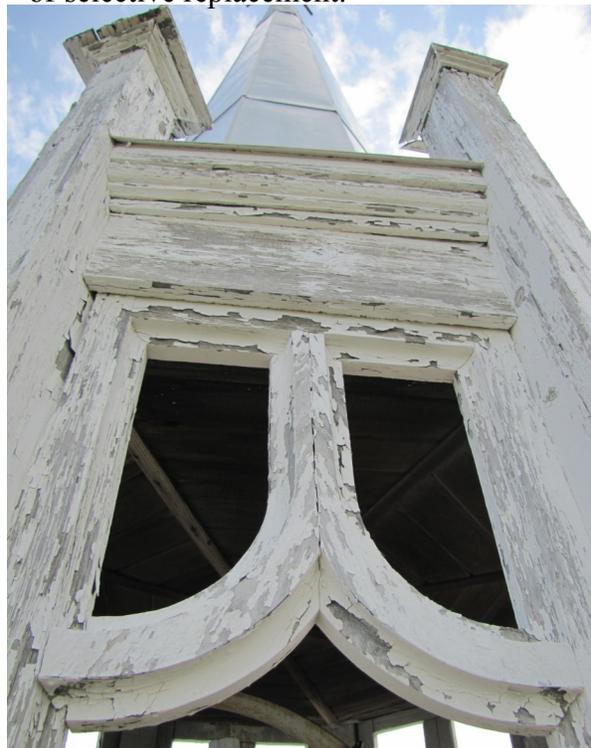
Fig. 14 — St. Mary’s Anglican Church, Maple Creek (Photo: M. G. Miller, 2011)

The timber spire at St. Mary’s Anglican Church in Maple Creek is a prominent feature in the local urban landscape. The deterioration of the spire has resulted primarily from natural weathering. Access to maintain the spire is an complicating factor. In terms of addressing the deterioration, the approach can range from conserving the spire in its current location to removing it for reconstruction. Standard 3 promotes the minimal intervention approach as a means to safeguard the integrity of the place and its heritage values.

In relation to “reconstruction”, the Standards and Guidelines do not recognize the reconstruction process as a conservation treatment. Given the three treatments, preservation, restoration and rehabilitation, two approaches to conservation of the church spire are possible, restoration and rehabilitation. Preservation is excluded in this instance because it would not be desirable to maintain the current condition of the spire without some degree of selective replacement.

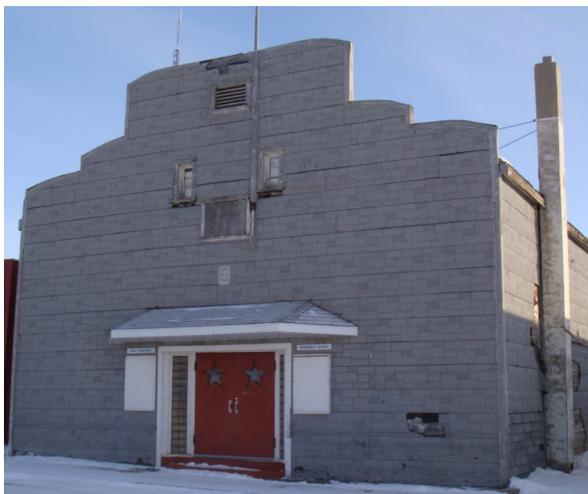
*Fig. 16 — Jax Theatre, Bengough
(Photo: M. G. Miller, 2009)*

Discussion: The exterior walls of the Jax Theatre in Bengough (Fig. 16) were believed to have been clad in asphalt shingles originally. While that particular material may not be the first choice if the theatre were being clad for the first time today, the material does represent a record of its time and place. It is possible that other buildings in the area may have been clad differently. However, if it were deemed desirable to re-clad the building using a horizontal metal siding that imitated the appearance of wood, this would amount to “creating a false sense of historical development.”

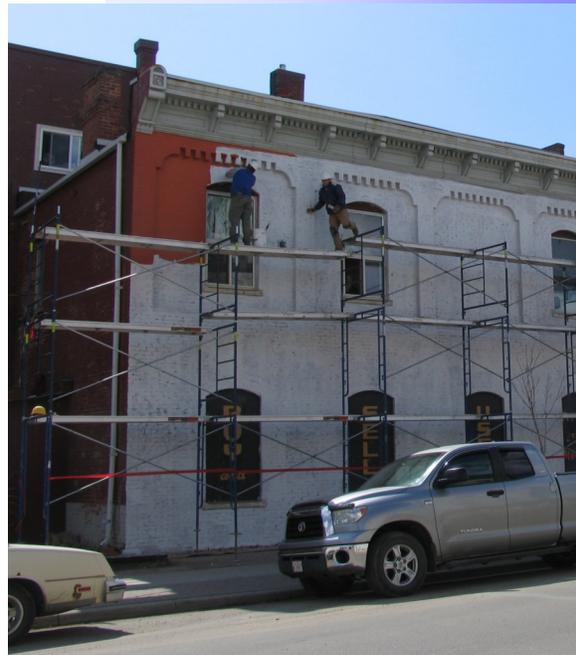
*Fig. 15 — Main Street, Prince Albert
(Photo: M. G. Miller, 2009)*

While painting exterior masonry can cause technical maintenance issues in the future, it can also blur the historical development of the place, particularly from an urban streetscape perspective. The unpainted masonry would be the physical record of its time, which should be subject to the processes of conservation.

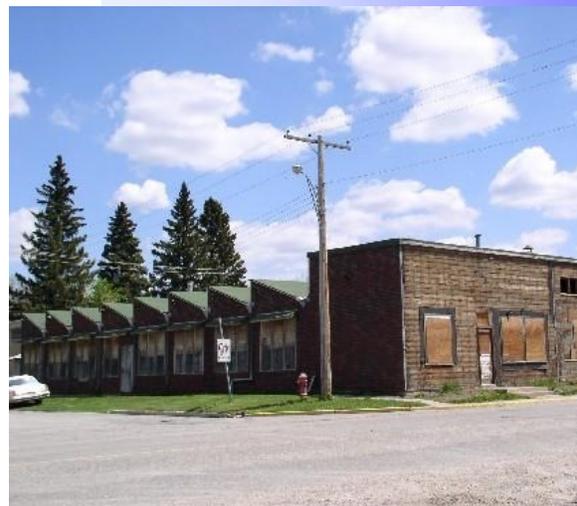
*Fig. 17 — Symons Metalworkers Factory, Rocanville
(Photo: M. G. Miller, 2009)*

The use of asphalt brick siding at the Symons Metalworkers Factory in Rocanville raises an issue since the original material is no longer produced in a way that would allow selective replacement. Instead, an “in kind” material that is readily available may satisfy the treatment described previously as rehabilitation.

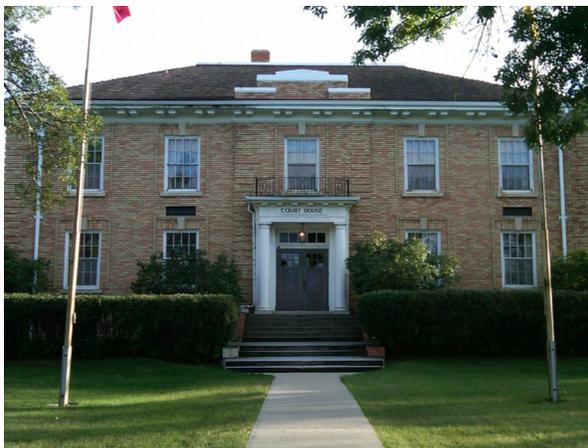
*Fig. 18 — Assiniboia Courthouse, Assiniboia
(Photo: M. G. Miller, 2011)*

When a proposal to convert the Assiniboia Court House to residential use was considered in 2011, it required code-compliance upgrades such as second exits and change-of-use requirements including an elevator. These types of code upgrades and contemporary amenities are often characteristic of new uses.

The design challenge is therefore not whether the building could accommodate a change of use, but rather whether the change of use is designed so as to minimize any adverse effects on character-defining elements. When the latter is achieved, it can be said that the use is compatible with the heritage values of the place and would therefore satisfy Standard 5.

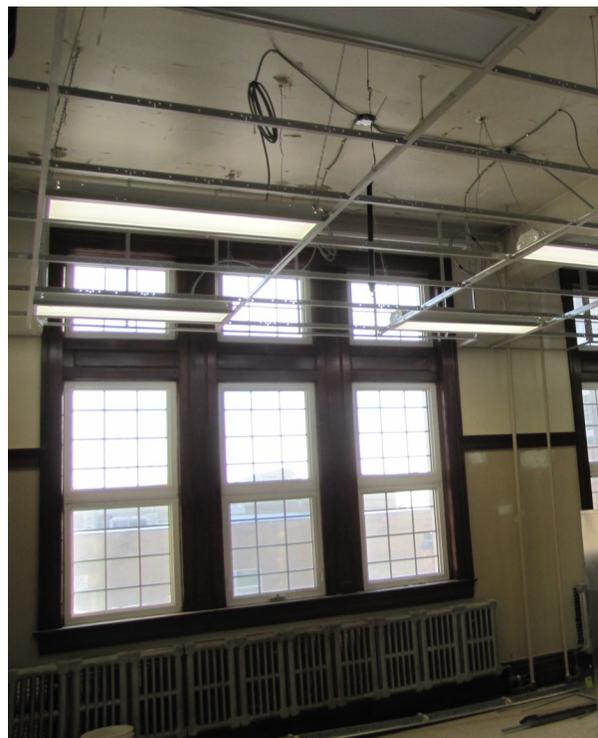
*Fig. 19 — E. A. Davies Building, Saskatoon
(Photo: M. G. Miller, 2011)*

When suspended ceilings such as those at the E. A. Davies Building in Saskatoon extend below the heads of historic windows, the appropriate resolution of the new work will determine the degree to which the new use is considered to be compatible. The visual impact of such additions should be considered from the inside as well as from the outside.

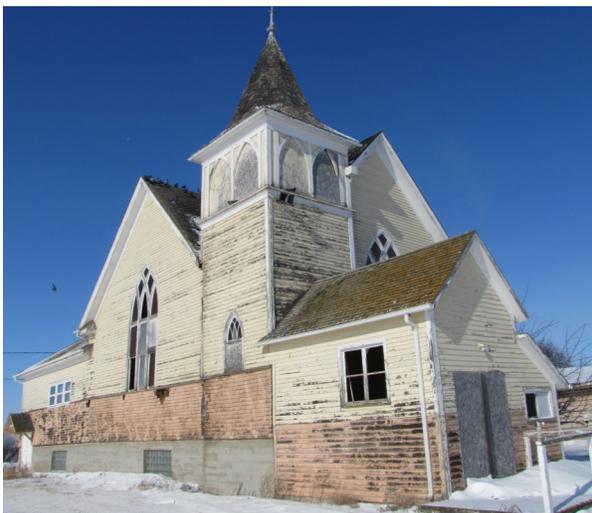
*Fig. 20 — vacant church, Drinkwater
(Photo: M. G. Miller, 2011)*

Discussion: Vacant structures are particularly vulnerable to damage, accelerated deterioration or destruction arising from being exposed to the elements or to the activities of humans. Temporary protection is therefore very important, even if it consists of boarding over windows, openings and areas subject to moisture infiltration. Vacant structures that are not afforded this basic level of protection would not satisfy Standard 6. This lack of protection can result in accelerated deterioration, which in turn, can increase rehabilitation costs when a new use is contemplated.

Structures require ongoing monitoring, maintenance and in some cases, interim stabilization that will arrest further deterioration until a longer term intervention is undertaken.

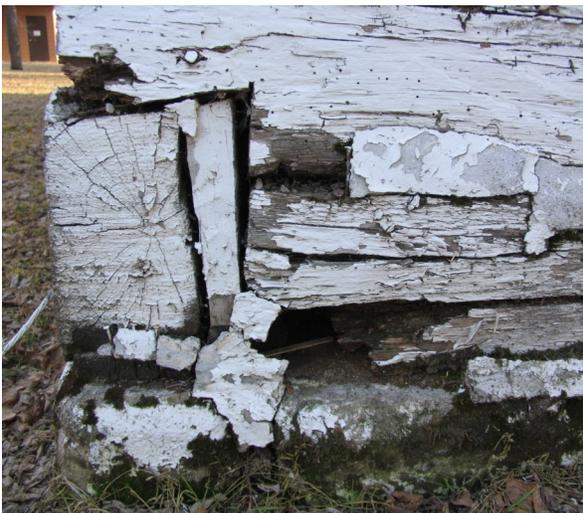
*Fig. 23 — Nisbet Church, Prince Albert
(Photo: M. G. Miller, 2011)*

The evaluation of condition can also relate to Standards 1 and 6, where the timeliness of evaluations becomes important. If the condition of historic character-defining elements remains unprotected from moisture or other causes, it would be considered that Standard 7 would not be satisfied.

Discussion: Whether a deteriorating log structure as depicted in Figure 23 (Nisbet Church in Prince Albert) or cracks in masonry walls as evidenced in Figures 49 and 50 (The Stoop in Rouleau), regular monitoring and maintenance to safeguard the structure from water infiltration is of prime importance. In many cases, defective or non-existing gutters or rain-water downspouts are major causes of exterior wall deterioration.

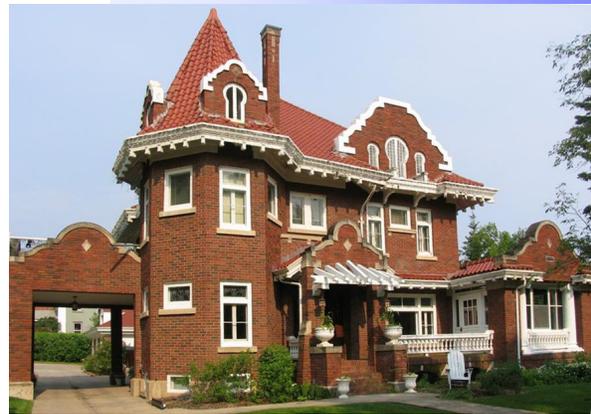
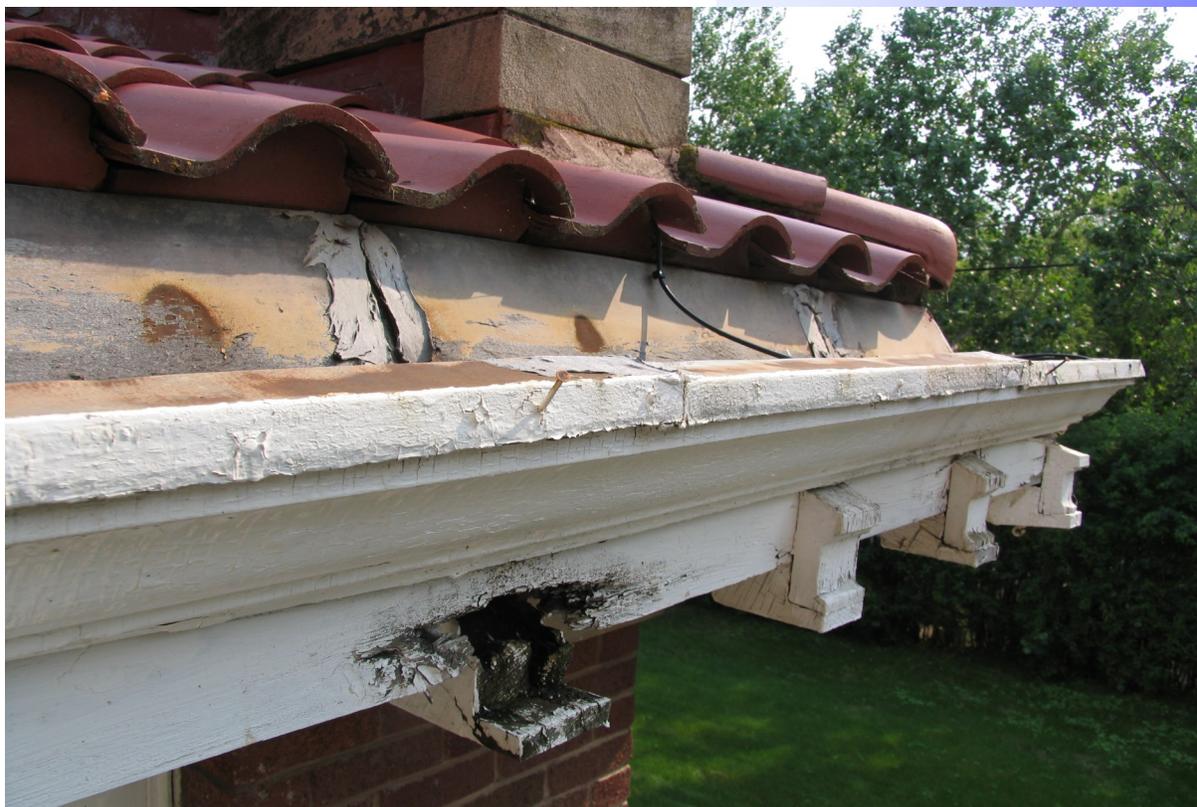
*Fig. 26 —Keyhole Castle, Prince Albert
(Photo: M. G. Miller, 2010)*

In Prince Albert for example, the timberwork below the eaves trough at the Keyhole Castle has been subject to deterioration arising from water moving into and around areas that are often concealed from easy view, while deterioration occurs. These conditions can be guided by the repair and in kind replacement approach outlined in Standard 8.

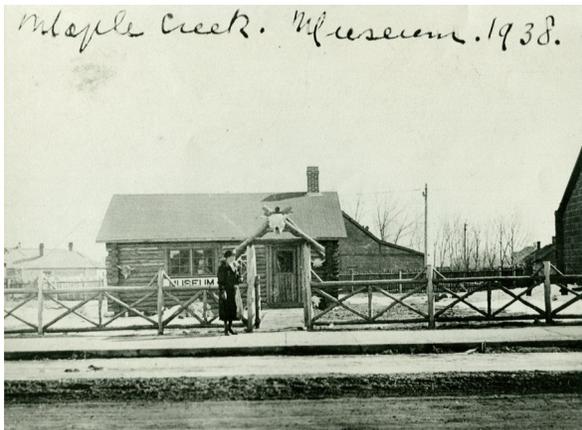
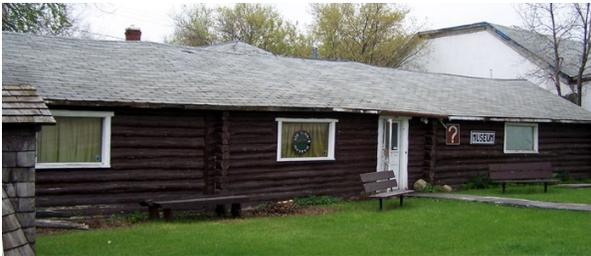
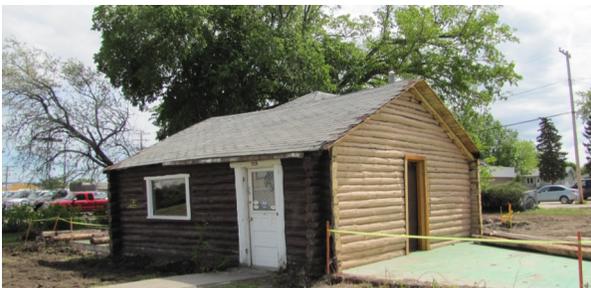
With the South West Saskatchewan Oldtimer's Museum in Maple Creek, the additions that flanked the original 1938 building were removed in 2011 in order to carry out essential repairs to the original structure and restore the building to its original appearance. In order to accommodate the Museum's expanding collection, a new larger addition is anticipated to replace the smaller wings and extend to the rear. The design approach requires that the addition be subordinate, compatible and distinguishable.

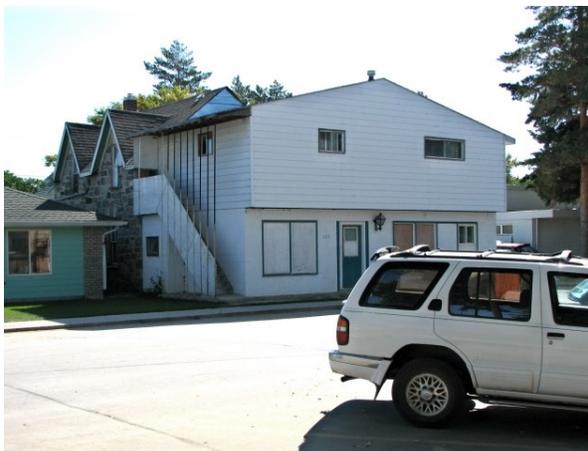
*Fig. 33 — Stone House, Fort Qu'Appelle
(Photo: Ken Collum, 2009)*

The addition to the Stone House in Fort Qu'Appelle (Fig. 33) is an example where the location, scale, design and materials of the two-storey, low-sloped roof addition accentuates its incompatibility with the historic stone house behind. While there can be no doubt that the addition is distinguishable, design solutions for additions to historic places must satisfy all of the relevant Standards i.e. not only must it be compatible and subordinate in relation to Standard 11, but it must also satisfy Standards 1, 2 and 3 in order to be considered to have met the Standards & Guidelines.

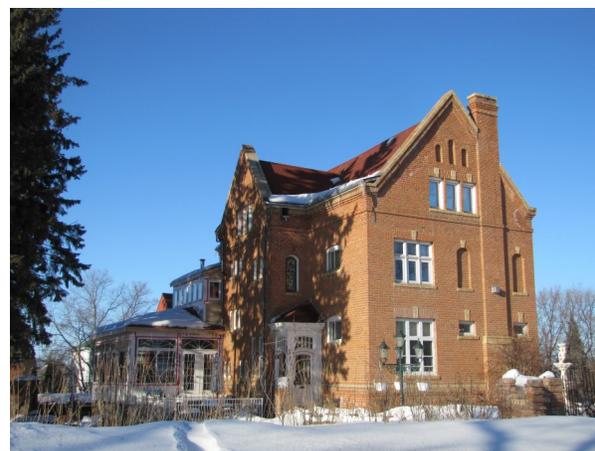
*Fig. 34 — Residence, Prince Albert
(Photo: M. G. Miller, 2011)*

A compatible addition should not imitate historic details in order to achieve compatibility. The scale, location and general form of the addition to the private residence in Prince Albert (Fig. 34) for example, is subordinate to and distinguishable from the historic place.

Standard 2 recognizes that conservation is not just limited to the 'original'. Change occurs. The Standards and Guidelines recognize that some change, such as that depicted in Figs. 3, 7, 9, 34 and 39, can be adverse and it is appropriate to remove such changes. In other instances, change may not be original, however, those changes may become important over time.

The exterior form of new additions should be compatible with the historic place and subordinate to it (see also Fig. 34). The characteristics of a subordinate relationship are not limited to scale alone but can also involve location, the relative importance of the historic entry and the visual impact of any new design.

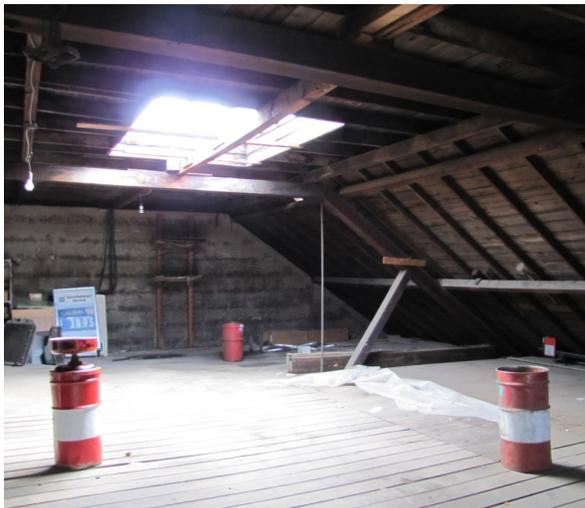
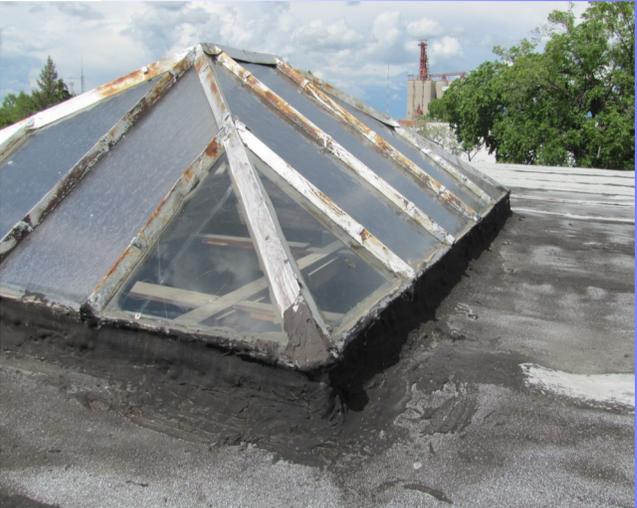
Fig. 35 — C. M. Glascock Heritage Building, Maple Creek (Photo: M. G. Miller, 2011)

For character-defining features such as the sky-lights at the C. M. Glascock Heritage Building in Maple Creek, options considered to address water infiltration included blocking the skylights up and roofing over their multiple locations. This approach would not constitute the minimum intervention, given the issue to be addressed and it would reduce the practicality of reversibility.

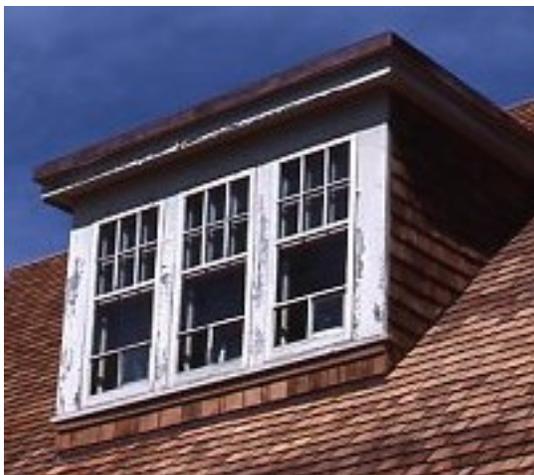
Fig.38 — Anson House, Diocese of Qu' Appelle, Regina—historic wood windows (Photo: F. Korvemaker)

In relation to the Anson House for example, the historic wood windows as depicted in Figure 38 are replaced by imitation PVC windows in Figure 39. The PVC windows present a very different design; the top lites are more horizontal and muntin bars are not true-divided lites. The frames of the historic windows are appropriately proportioned whereas the proportionality of the PVC windows noticeably changes the historic character of the place.

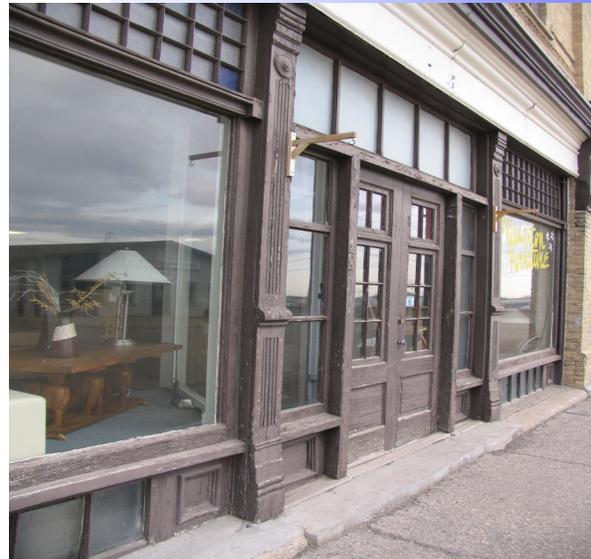
Fig. 41 — McNaughton Stores (1886 Building),

In addition, physical evidence that is *in situ* (that is, existing in its original position), as depicted in Figure 41, could directly assist in the repair and reinstatement of missing components of the nearby storefront depicted in Figure 42. Such evidence-based replacement would satisfy Standard 14, however, poor - quality archival photographs or other sources which do not provide adequate detail in order to instill a high-degree of accuracy in any restoration, would not satisfy Standard 14.

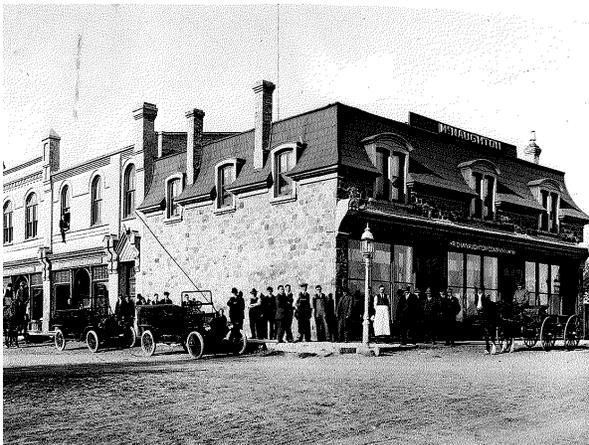
Fig. 40 — McNaughton Stores, Moosomin , 1898
(Photo: Saskatchewan Archives Board)

For example, the aluminum windows featured at the lower right side of Figure 43 could be replaced with new windows whose form, material and detailing are based on documentary evidence of the historic wood windows that are now missing and featured in Figure 40, however, the level of detail is inadequate to facilitate an accurate restoration.

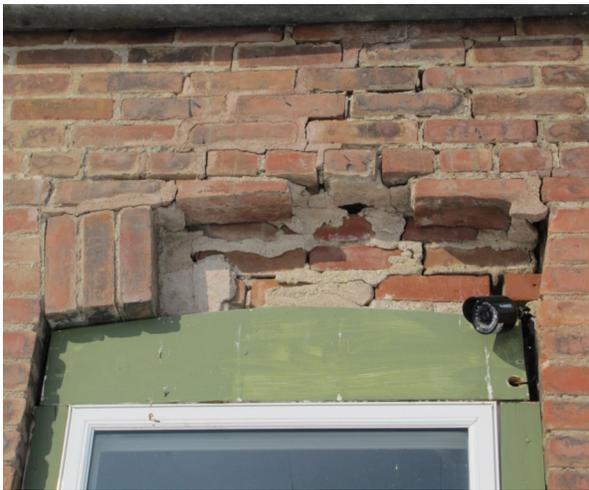
Fig. 49 — The Stoop, Rouleau
(Photo: M. G. Miller, 2011)

In Saskatchewan, masonry re-pointing with the appropriate mortar is important to ensure material compatibility and to prevent water from getting into cracks and being subject to the freeze-thaw cycle where significant damage to masonry can occur.

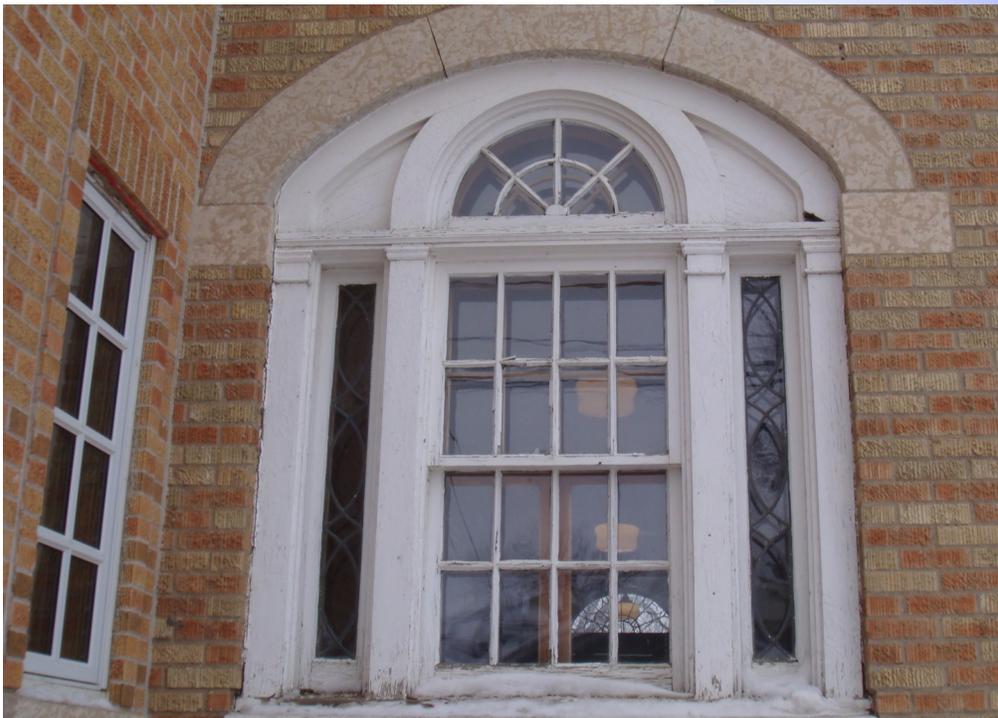
Fig. 51 — Estevan Courthouse, Estevan
(Photo: M. G. Miller, 2009)

When the historic windows at the Estevan Courthouse were replaced (left side of Fig. 51) with PVC windows, a noticeable difference in character was created between the new windows of a different material and design, and the historic windows (centre of Fig. 51). The historic double-hung wood sash has narrow through (vertical) muntin bars and a shadow line is created at the substantial meeting rails (the larger central horizontal window element). The replacement window has wide imitation muntin bars, no meeting rail and lacks a sense of depth and detail.

When replacing a historic window (sash and/or storms) that is too deteriorated to be repaired, it should always be replaced *in kind*. In kind means that the replacement window must be materially, functionally and architecturally the same as the historic

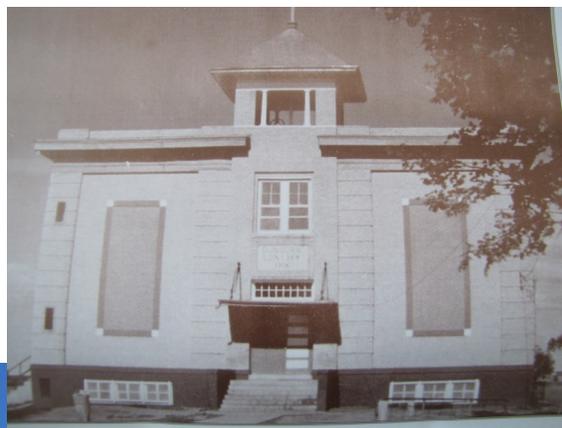
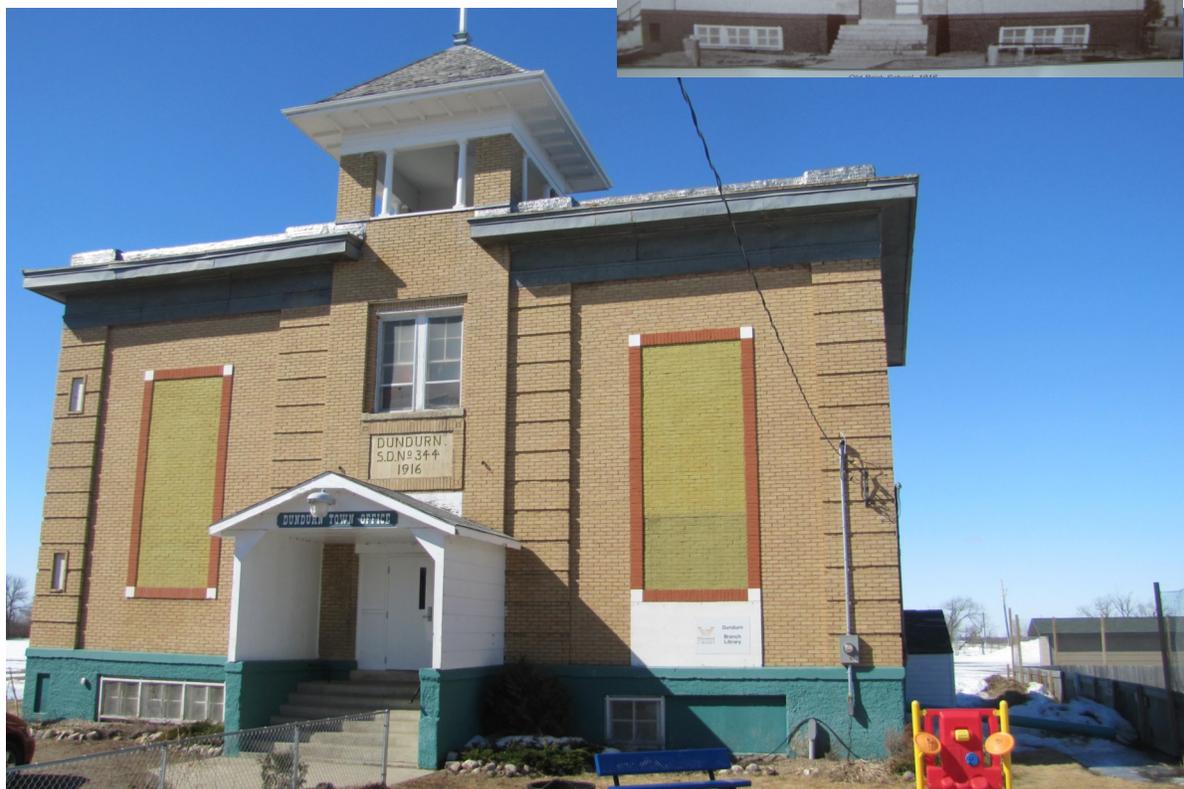
Fig. 52 — Old School, Dundurn (Photo: M. G. Miller, 2011)

Archival photographs of the Old School in Dundurn show a multi-light transom window that could be reinstated even if a windbreak in the form of an exterior addition were deemed necessary. In this regard, Standards 2, 3 and 9 would be particularly relevant.

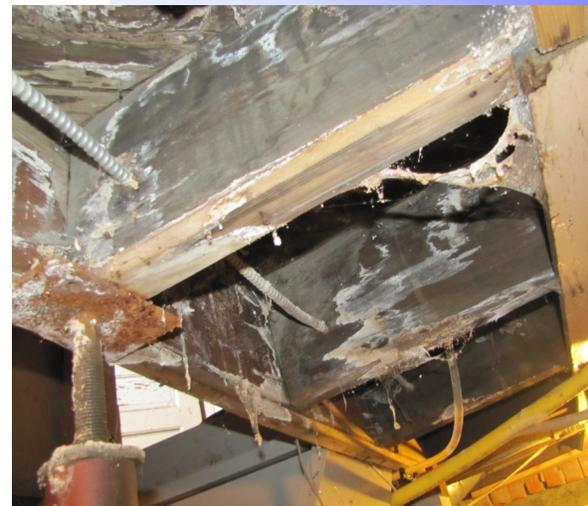
Fig. 55 — The Stoop, Rouleau
(Photo: M. G. Miller, 2011)

Discussion: Whether a deteriorating timber floor structure, as depicted in Figure 55, or the disintegration of a masonry wall, regular monitoring and maintenance to safeguard the structure from wet rot, dry rot, infestation or settlement due to inadequate support or surrounding soil conditions are of paramount importance. In many cases, defective or non-existing rainwater gutters or downspouts contribute to foundation deterioration. Unattended leaking parapets, valleys and roofs can allow water to become trapped, leading to significant and often costly damage to structural systems.

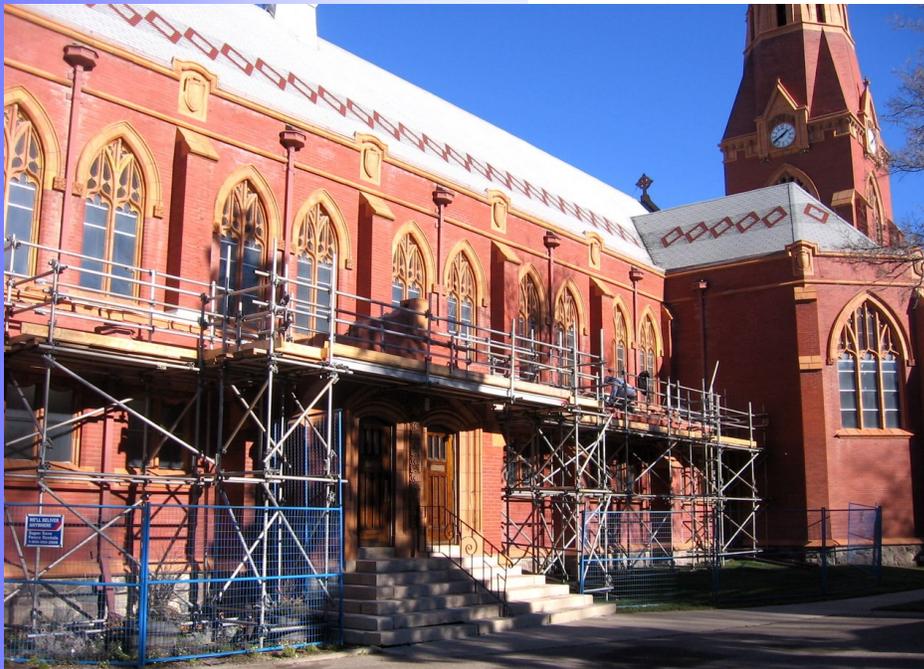
Fig. 56 — Cathedral of St. John the Evangelist, Saskatoon (Photo: R. Halliday, 2011)

Repairs to the side aisle roofs including the careful removal, recording and reinstatement of the decorative terra cotta is considered to be consistent with Standards 3, 6, 7, 8 and 10.
